# Your survey report

100 Smith Street, Oxfordshire, OX1 5DZ.

July 2021.

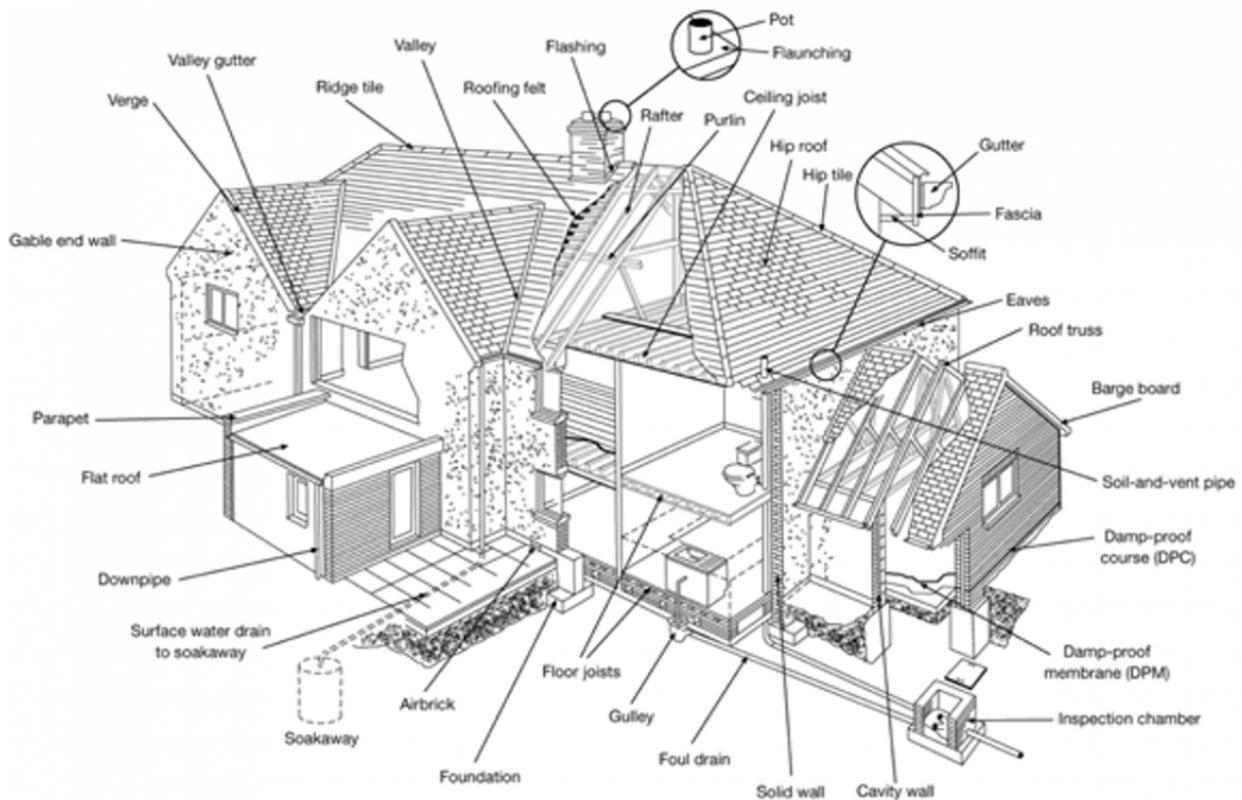
## Typical house diagram

This diagram illustrates where you may find some of the building elements referred to in the report.
