LEVEL 3

Your survey report...

100 Smith Way, Oxford, OX1

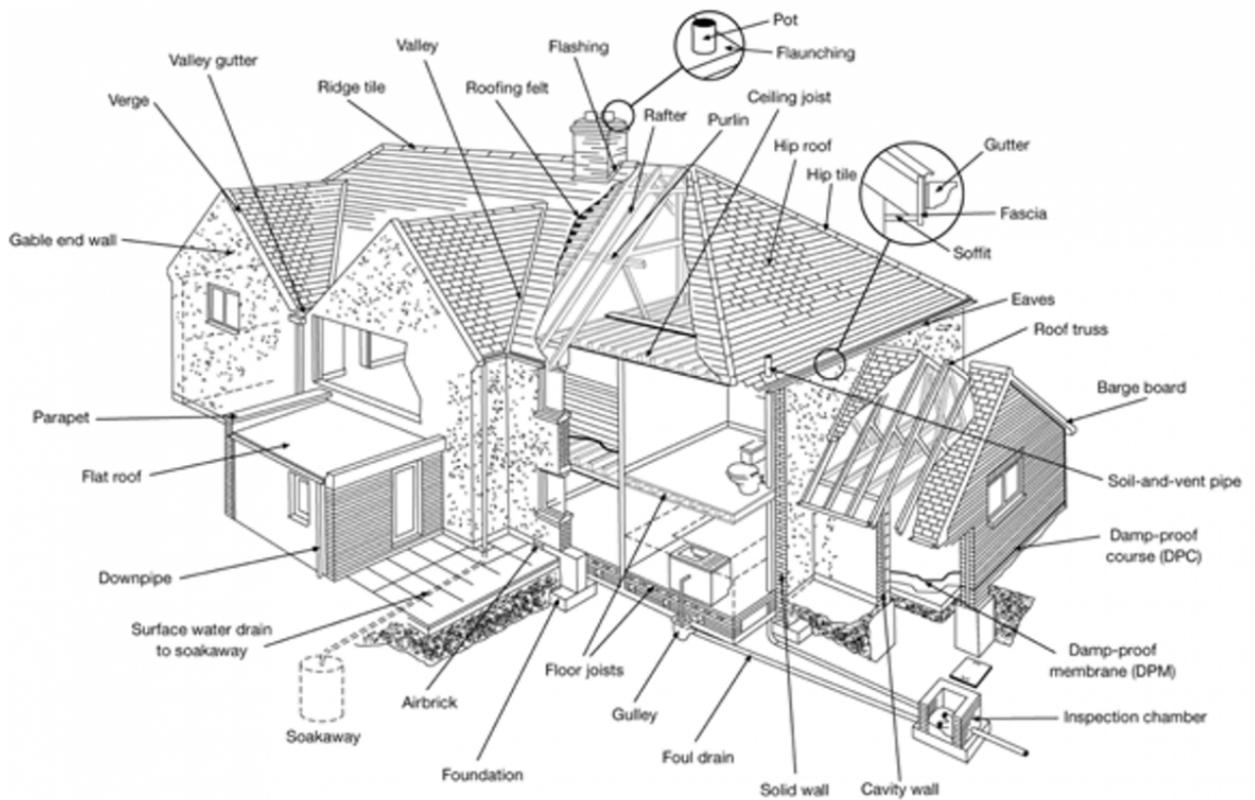
Typical house diagram

This diagram illustrates where you may find some of the building elements referred to in the report.
