RICS
Building Survey

- A Introduction to the report*
 - B About the inspection
 - C Overall opinion and summary of the condition ratings
 - D About the property
 - E Outside the property
 - F Inside the property
 - G Services
 - H Grounds (including shared areas for flats)
 - I Issues for your legal advisers
 - J Risks
 - K Energy efficiency
 - L Surveyor's declaration
- What to do now
Description of the RICS Building Survey Service
Typical house diagram

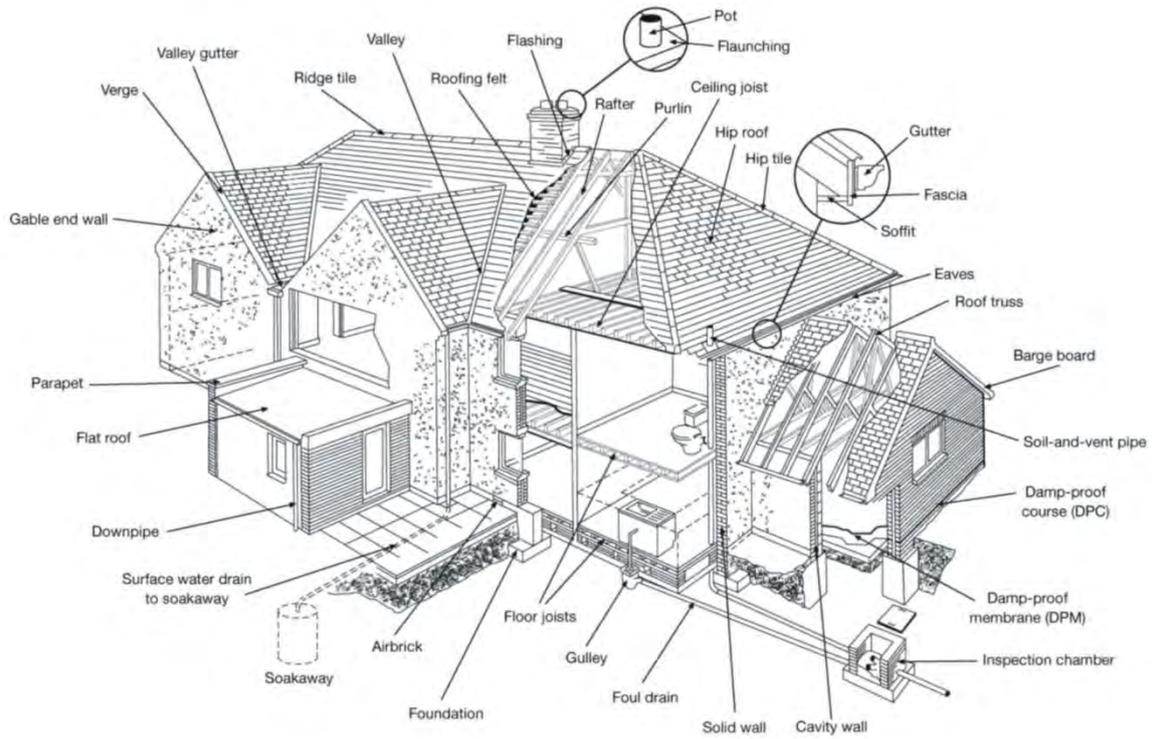
This diagram illustrates where you may find some of the building elements referred to in the report.
